PRELIMINARY ASSESSMENT REPORT

Doyle, Frank J.

EPA ID NO. TXD980865109

LEONARD, FANNIN COUNTY, TEXAS

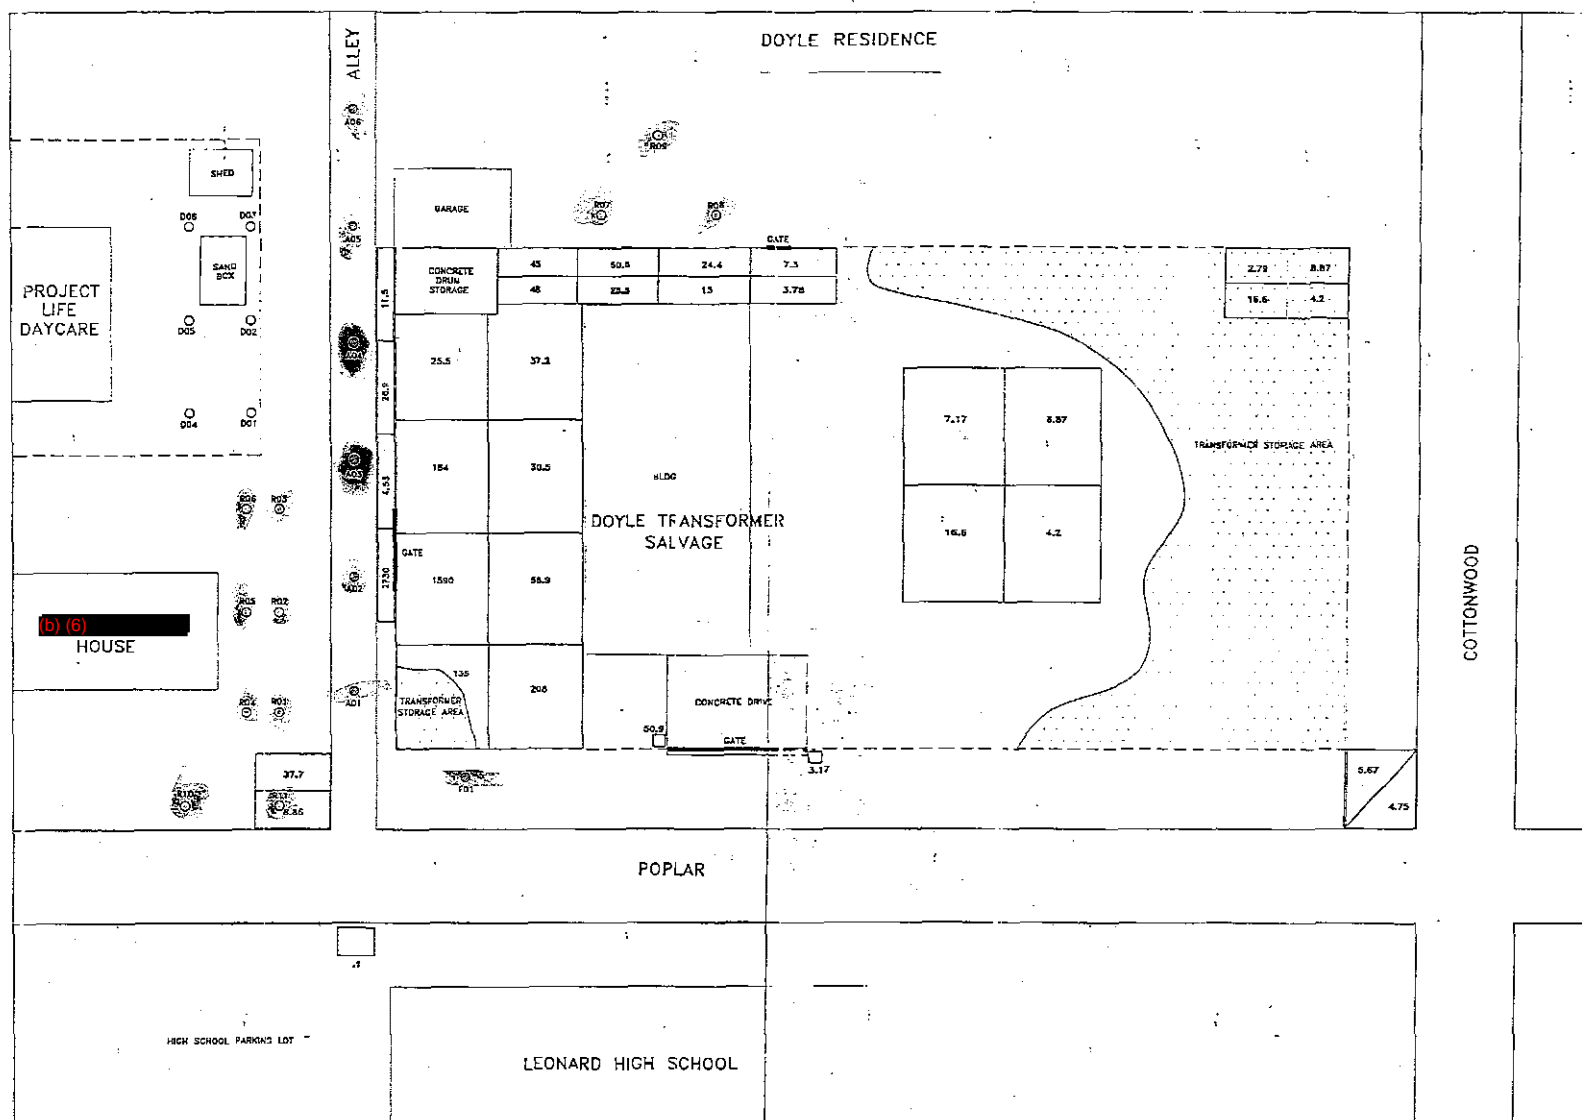
Figure 3
Sample Location Map

Soil samples were also collected in the alleyway between the site and the residence. Sample AO1 had the highest Aroclor 1260 concentration of 5.7 ppm in the 0-6 inch interval and 48.2 ppm for the 12-18 inch interval. Sample AO2 had the highest Aroclor 1260 concentration of 852 ppm at the 6-12 inch interval and a concentration of 115 ppm for 18-24 inch interval. Both of these sample locations are located across the outside storage area for the transformers and down gradient from the site (Figure 3- Sample Results Map).

The highest concentration of Aroclor 1260 found on site was 1590 ppm. It was a grab surface soil sample collected near the gate located on the east side of the property. Another grab surface soil sample was

collected just outside the east gate with a concentration of Aroclor 1260 of 2730 ppm. This location is outside the fenced perimeter of the site and is assessable to the public. A grab soil sample was also collected at the location of the culvert and the analytical results showed the third highest concentration of PCB Aroclor 1260 with a 50.9 ppm concentration (Figure 3).

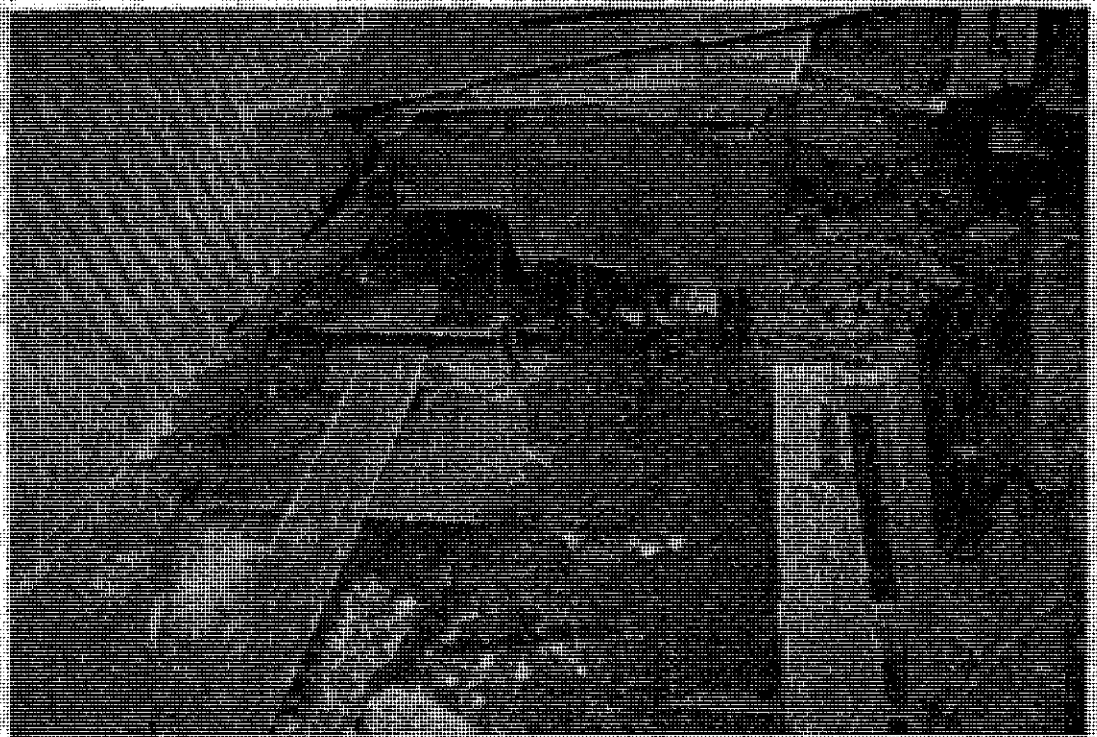
Photo No.
2
Neg. No.
2

500 stumps located outside the shed. Notice the deterioration of the of the metal building.

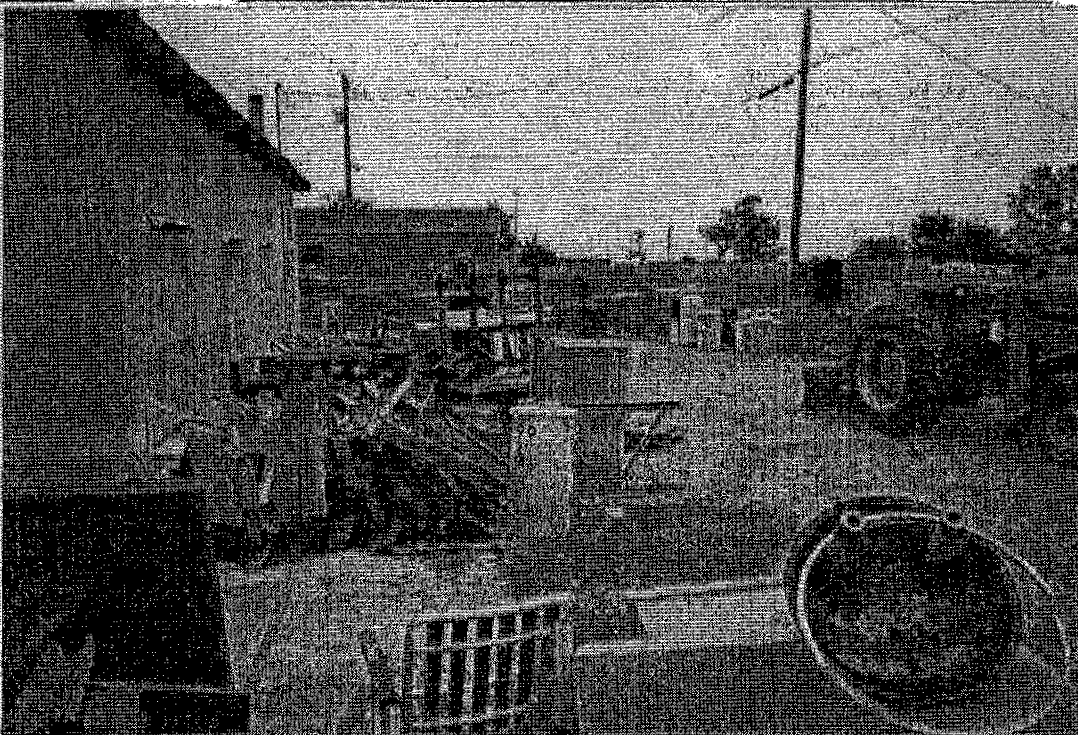
Photo No.
9

Description The south side of the shop. Soil staining was located near the debris pile.

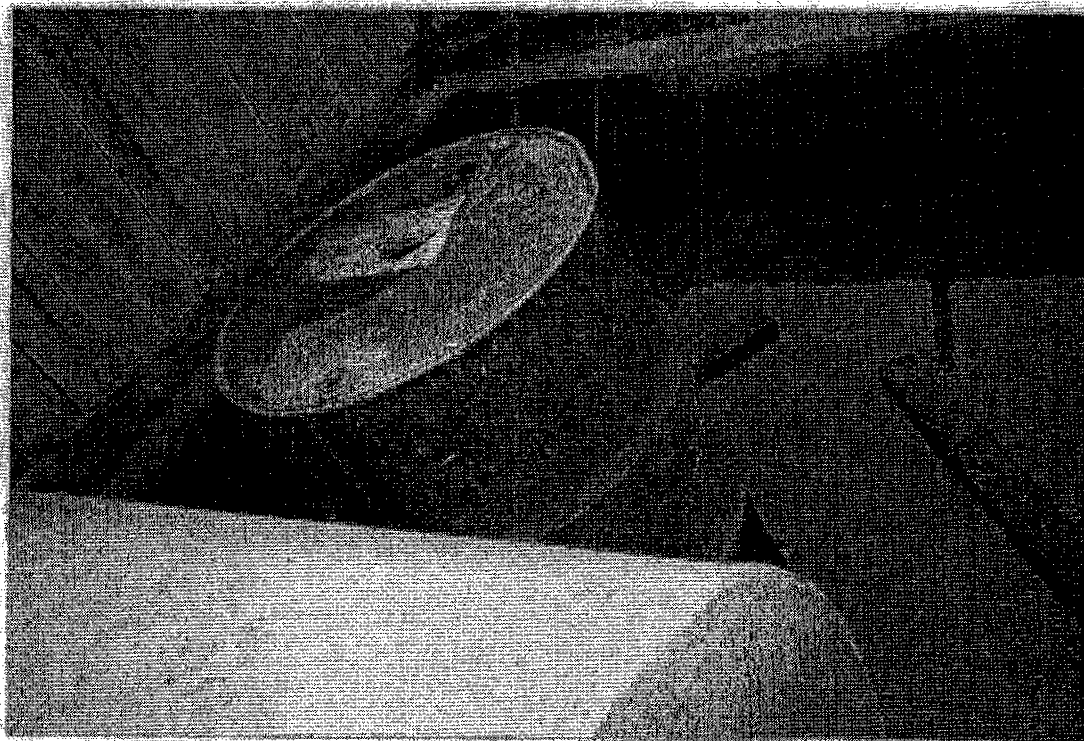
Photo No.
10

The Frank J. Doyle Transformer site is completely fenced and has secured locks on all the gates. The ground cover consists of a mixture of gravel and concrete. The ground inside the shop and the entrance into the main gate is covered with concrete. The rest of the salvage yard is covered by gravel except for the concrete containment area located in the southwest corner of the property. The pad was used to store sixteen 55-gallon drums. Of the sixteen drums only one drum was labeled as "Non-PCB", the remaining drums were not labeled (Photo #3). The concrete pad showed signs of deterioration (Photo # 12). The pad is located adjacent to a concrete containment area that contains two 500 gallon storage tanks and one 375 gallon tank (Photos #10 & 11). Inside this concrete containment area, there was a rusted 55 gallon drum that was marked as corrosive (Photo #10). It was observed and later confirmed by Mr. Doyle that this was the location where waste oil from the transformers is stored prior removal (Photo #12). The used oil is vacuumed out of the holding tanks by a transportation company named Scroggins which is out of Oklahoma [Reference 11]. There was evidence of spilled or leaking oil near the concrete containment area on the day of the site reconnaissance and a yellowish/green staining along the fence line near the

disposal point (Photo #10). Prior environmental assessments that were conducted on and off-site have revealed PCB contamination in the soils. The laboratory results of the soil samples collected on and off-site are discussed in section 2.3.

305 E. Cottonwood Street Description View of the drum marked as corrosive inside the tank pit holding area.

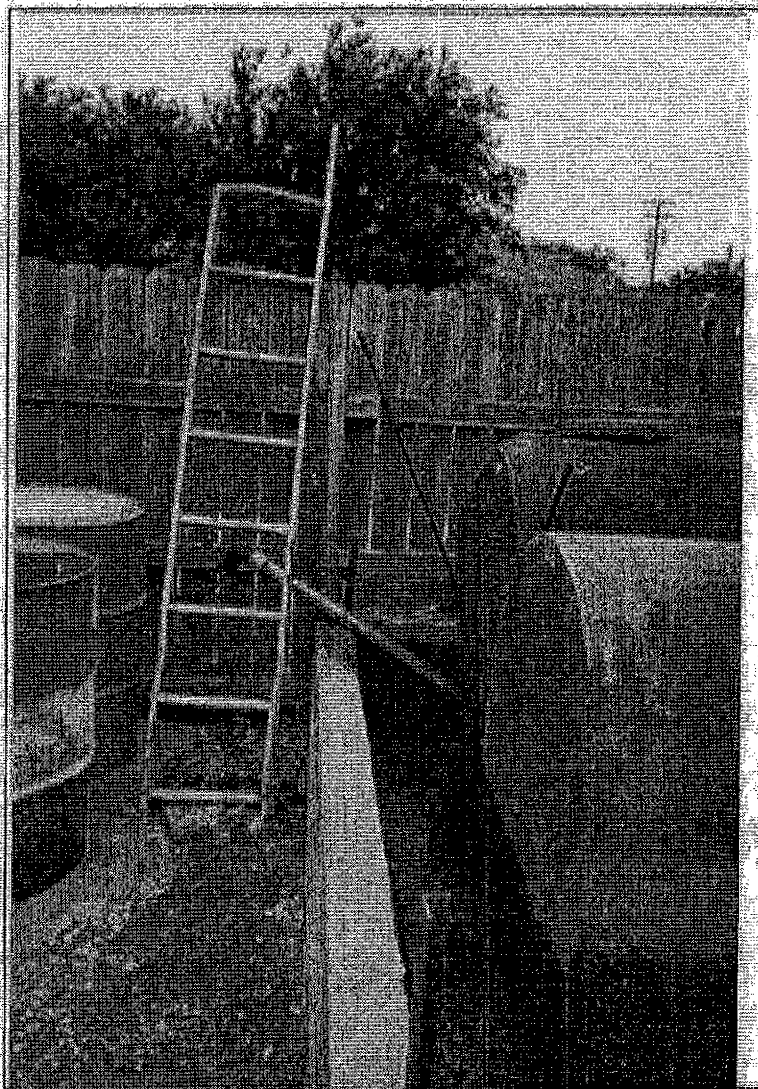
Photo No.
12
Neg. No.
10

Photographer/Witness: *WP* W. Bigley / K. Westberry
Date: 05/20/97 Time: 10:25 Direction: North
Description: Waste oil containment structure. Also shown is the location of waste collection for off-site disposal.

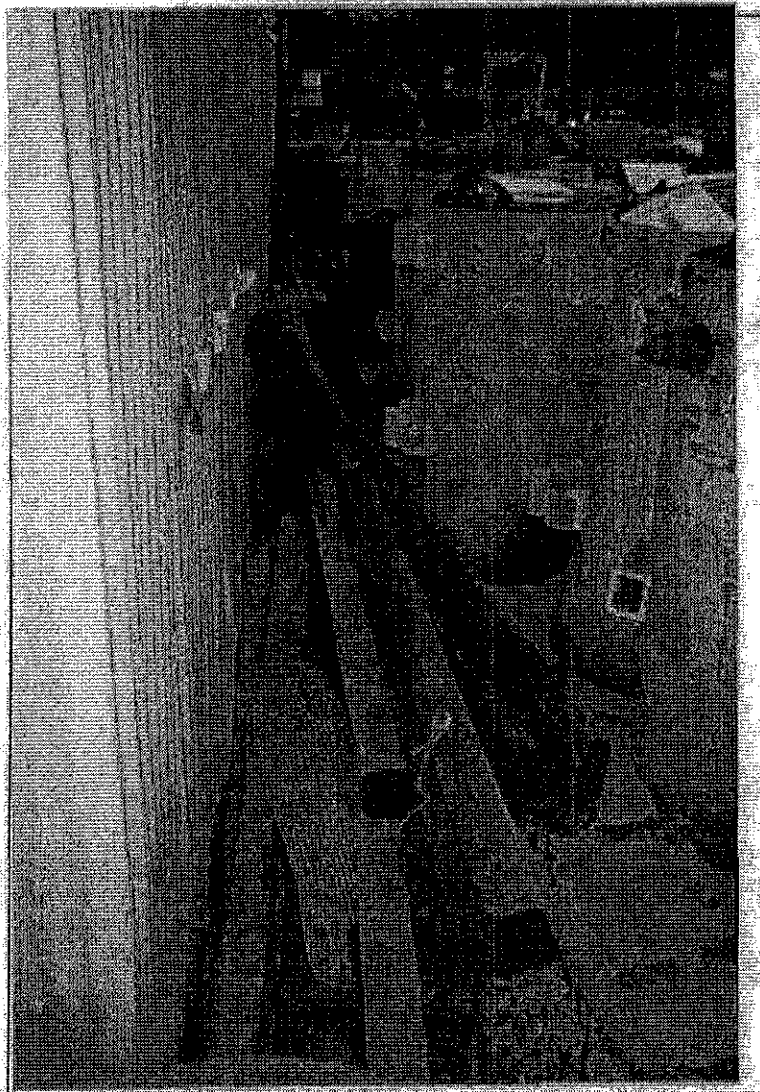
Photo No.
16

Photographer/Witness W/B W. Bigley/ K. Westberry
Date: 05/20/97 Time 10:30 Direction East
Description View along the north side of the shop. Note the staining and the condition of the transformers.
